Composting Toilets and Water Harvesting: Alternatives for Conserving and Protecting Water in Nogales, Sonora

January 2010

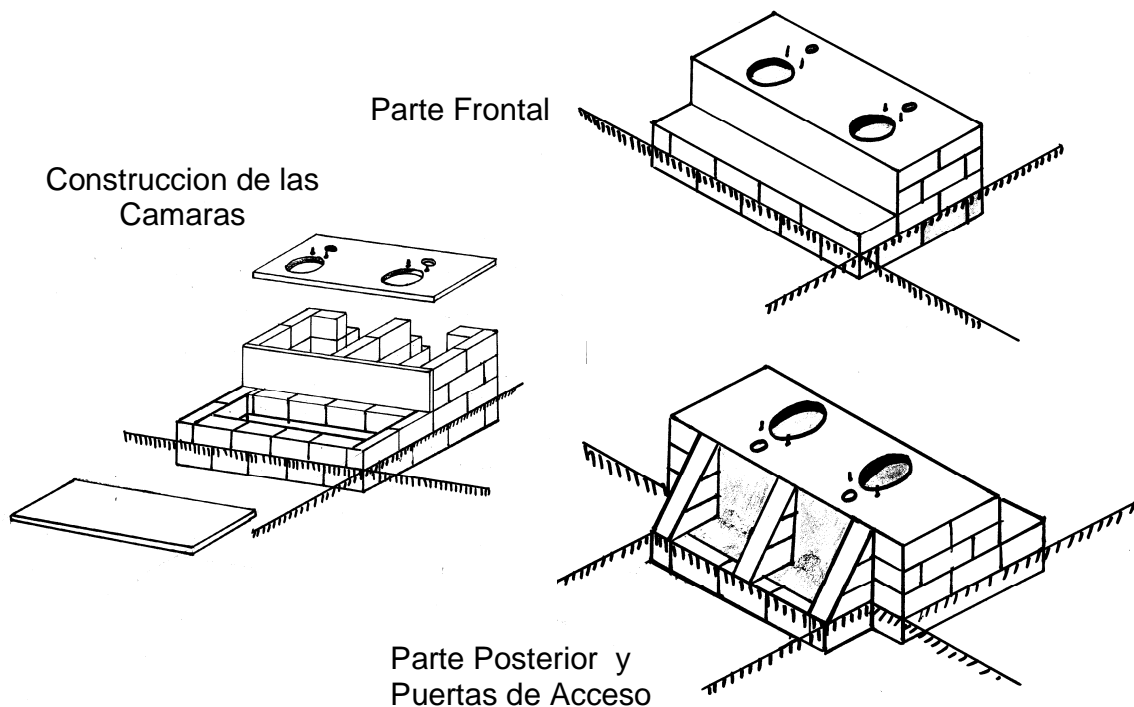
Figure 2. Sketch of Composting Toilet

environment of Nogales. The advisory board members reviewed and discussed toilet designs and approved the design shown in Figure 2, which included the following features:

- Two chambers, one in use and the other within which the aerobic process of decomposition takes place, plus four walls and the roof.
- The back side of the facility from which the compost is drawn out oriented toward the sun whenever possible.

- One chamber made of cinderblock 44in deep x 80in wide x 27in high, divided to create two sections, open at the bottom and with a cement slab placed on top to serve as the toilet seat. The chamber structure functions as the foundation for the walls that can be made of cinderblock or fibrous concrete blocks.

- A 4 inch PVC pipe from inside the chambers to the outside to promote ventilation.
- Two deposit chambers, each with a 20 by 24 inch back door to be used in taking out the compost.

- A gasketed toilet seat and lid.
- A screen placed over the ventilation opening.
- Careful sealing of cracks and openings.
- Facilities can be located next to a house with access from the inside or outside and either connected to or separated from the main house.

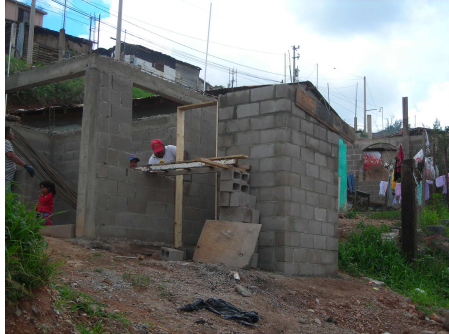
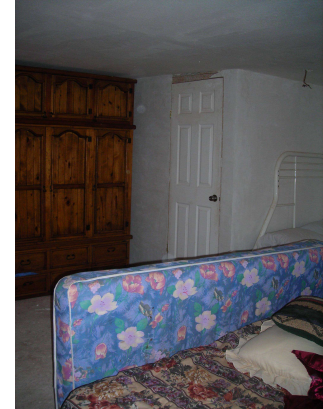
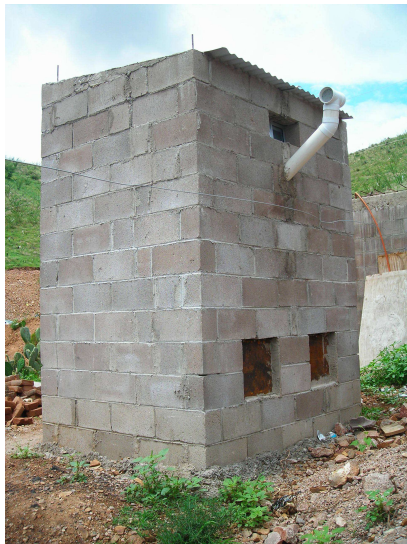
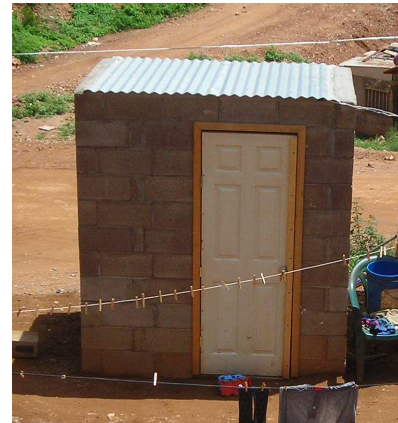
Figure 3. Photos of Composting Toilets

Two styles of toilet were constructed, within the house and outside the house, as shown in Figure 3. Initially, most residents were reluctant to construct the toilets within their houses, either because their house was constructed of wood and other materials and they planned to upgrade it or because they perceived the composting toilets to be like pitholes and could not imagine one within their homes. As the project progressed and residents were able to observe how the toilets of their friends and neighbors were operating, several more individuals requested toilets inside their homes. In addition, several residents who were constructing cinder block homes began to build their homes around their toilets.

Inside the house

Outside the house

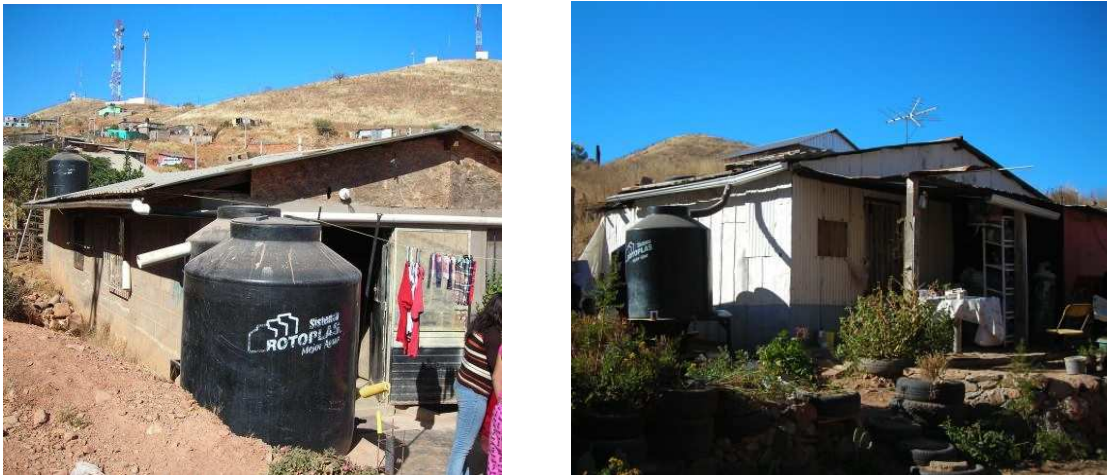
Figure 4. Photos of Active Household Water Harvesting Systems

Three active water harvesting systems were constructed between July 5 and October 31 (see Figure 4). All three systems have gutters, downspouts, and a large tank for storing rainwater. Construction at all three sites was delayed due to irregularities in the initial construction of the buildings, problems coordinating work schedules for those constructing the systems, problems finding materials in Nogales, Sonora, and challenges faced by those receiving the system in pulling together the resources to obtain the tank (being able to commit resources toward the purchase of the tank was one of the criteria used for selecting the recipients of the systems). The systems were designed to include a first flush system, but the first flush devices had to be ordered and shipped from Australia, and those were designed to be used with 3 inch tubes. Because 4 inch tubes are much more common, and less expensive, in Nogales, Sonora, and one of the three buildings already had pipes to which to connect, constructing systems that could incorporate first flush devices proved difficult.
